AMPACITY DERATING FACTORS FOR MINE TRAILING CABLES COILED ON REELS

This technical guide is focused on the derating factors for round mining cables coiled on reels.

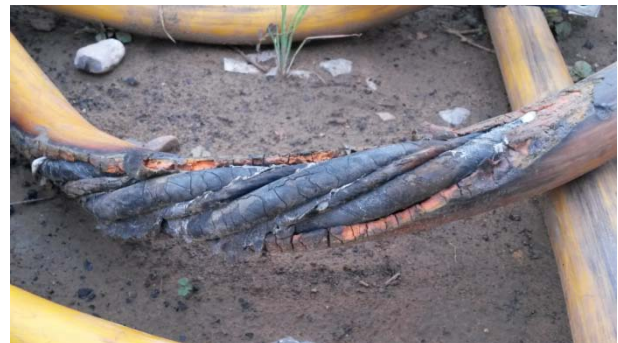
Fig. 1. Cores deterioration in a trailing cable.

After withstanding repeated exposure to temperatures exceeding the normal operating temperature rating of the insulation, breakdown or deterioration of the conductor's insulation and the overall jacket will result. Degraded cable insulation can result in a short circuit that may cause a fire or explosive release of energy.

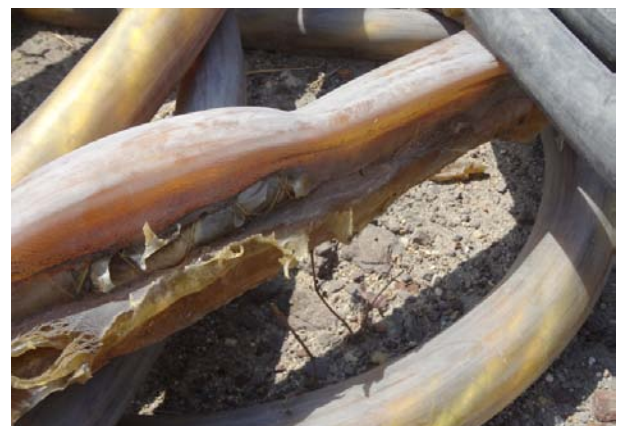
Fig. 2. Polyurethane jacket melted by overheating.

When a section of cable jacket is found to be melted or cracked due to excessive heating, the entire length of cable should be replaced and the techniques to minimize cable heating should be considered.

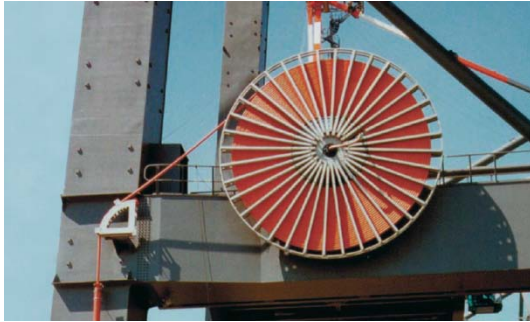
Fig. 3. Monospiral reel or radial drum (Ventilated)

Correction factor for less than 10 layers
Ventilated reel	0,8
Unventilated reel	0,7

Table 2. Ampacity derating factors for round cables coiled on radial drums.

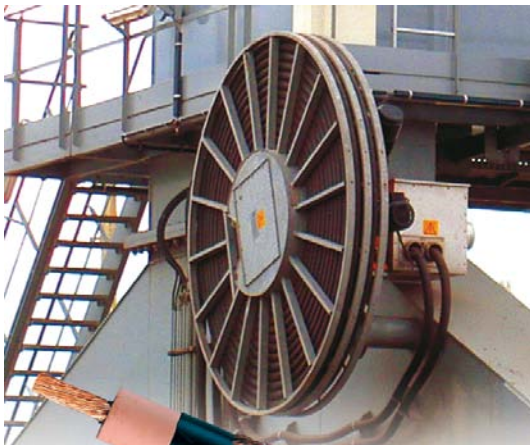
Fig. 4. Monospiral reel or radial drum (Unventilated)

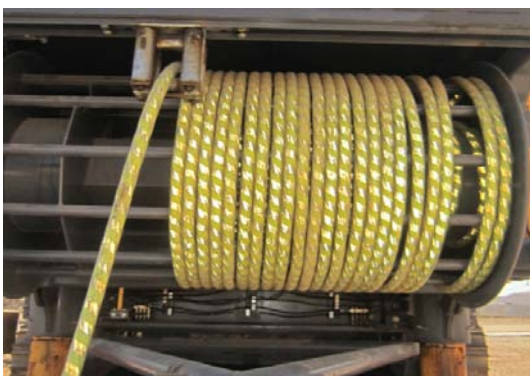
Fig. 5. Multi-spiral reel or cylindrical drum.

STANDARD	NUMBER OF LAYERS					
	1	2	3	4	5	6
OMSHR / NIOSH	0,67	0,49	0,39	0,31	0,26	0,23
DIN/VDE	0,80	0,61	0,49	0,42	0,38	-
ICEA/NEMA	0,85	0,65	0,45	0,35	-	-

Table 1. Ampacity derating factors for round cables coiled on cylindrical drums.

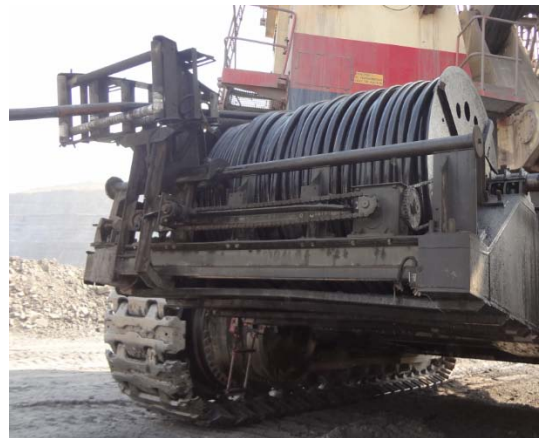
Fig. 6. Multi-spiral and multi-layer reel or cylindrical drum.

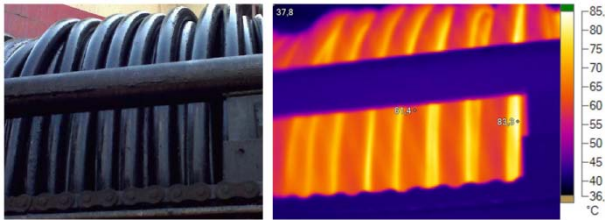
A thermal IR image of a SHD cable coiled in several layers is shown in Fig. 7, the brightest area of the image shows jacket surfaces of inner cable layers with temperatures higher than 83°C which means that copper conductors reach temperatures about 110°C (20°C more than the maximum operating temperature).

Fig. 7. Visible and thermal IR images of a cable coiled on several layers.
